K-4284  
BLUE SPRINGS

NPIC/CSD 556/65  
31 OCTOBER 1965  
PAGES 2  
PAGE 1 OF 2  
COPY 1

HIGHWAY BRIDGE  
THAI NGUYEN, NORTH VIETNAM  
2135N 10550E

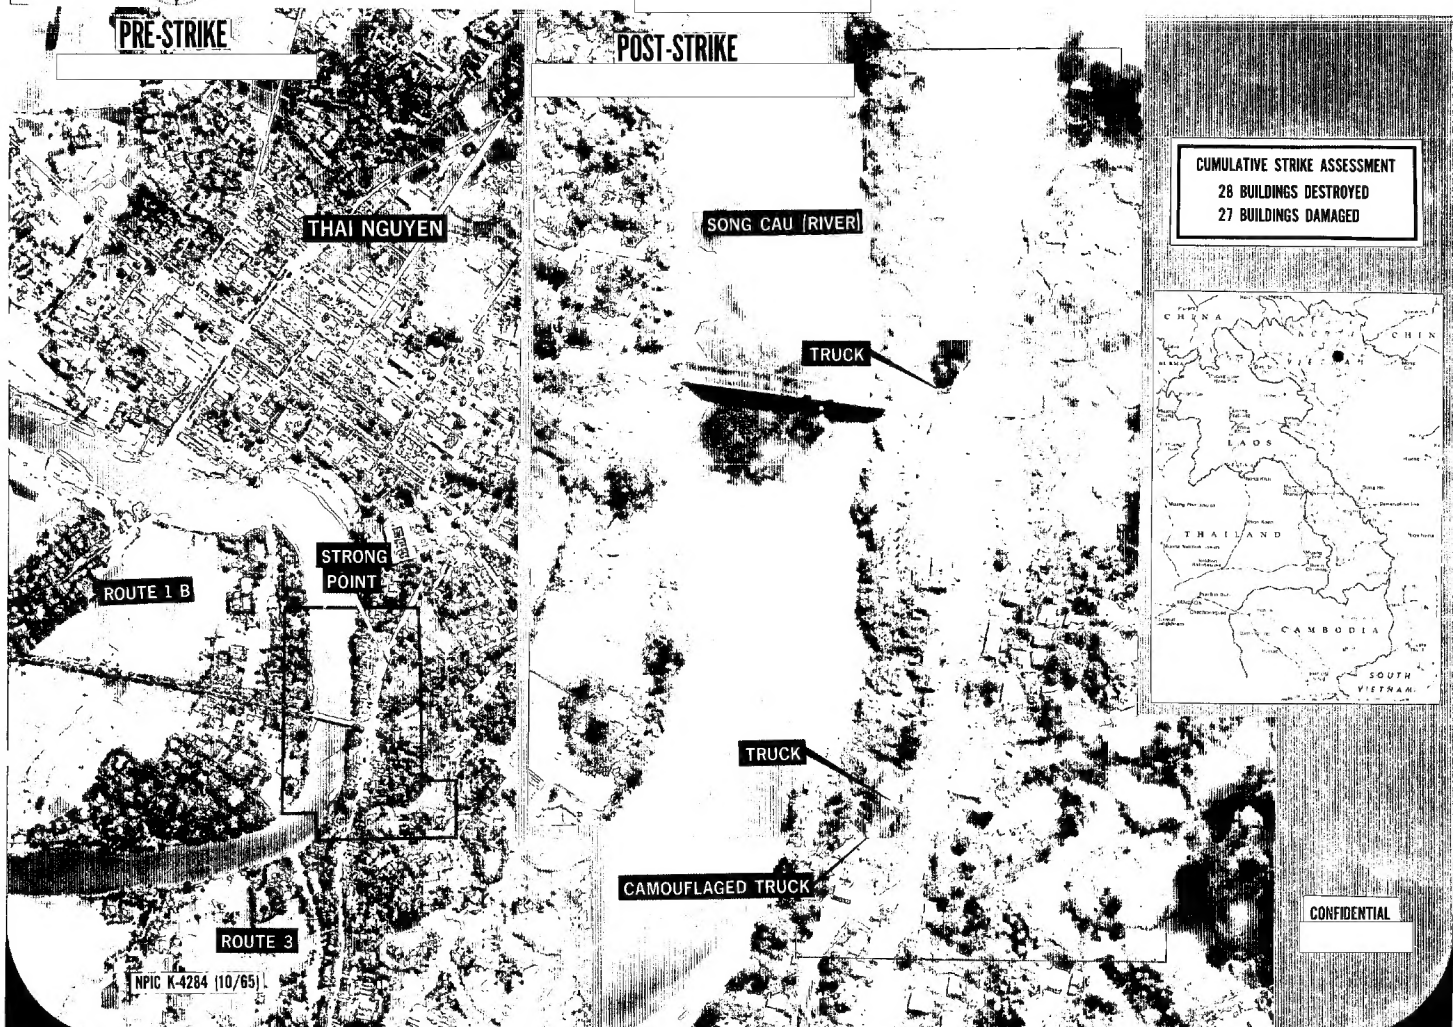
NPIC K-4284 (10/65)

REVEALS A FIVE-SPAN, CONCRETE, 235 X DECK-TYPE BRIDGE LOCATED 0.5 NM WEST OF THAI NGUYEN ON ROUTE 13 OVER THE SONG CAU (RIVER). THE BRIDGE IS SERVICEABLE. A STRONGPOINT CONSISTING OF TRENCHING, WITH FIRING BAYS AND AUTOMATIC WEAPONS POSITIONS, IS OBSERVED IMMEDIATELY SOUTHEAST OF THE SOUTHERN APPROACH TO THE BRIDGE.

REVEALS SEVERAL CRACKS ACROSS THE WIDTH OF THE CONCRETE DECK AND SEVERAL HOLES IN THE DECK SURFACE. THE SOUTHERN APPROACH TO THE BRIDGE IS INTERDICTED AND THE NORTHERN APPROACH IS DAMAGED DUE TO THE PROBABLE SHIFTING OF THE NORTHERN ABUTMENT. THE BRIDGE IS PROBABLY SERVICEABLE TO LIMITED VEHICULAR TRAFFIC.

# HIGHWAY BRIDGE THAI NGUYEN, NORTH VIETNAM 21-35N 105-50E

PRE-STRIKE

POST-STRIKE
